Vol. 04, Iss. 3 (2026) 343-354, DOI: 10.61552/JME.2026.03.004

Journal of Materials and Engineering

Silica Induced Tribological Degradation in an Industrial Pelletizer Bearing: A Multiscale Failure Analysis

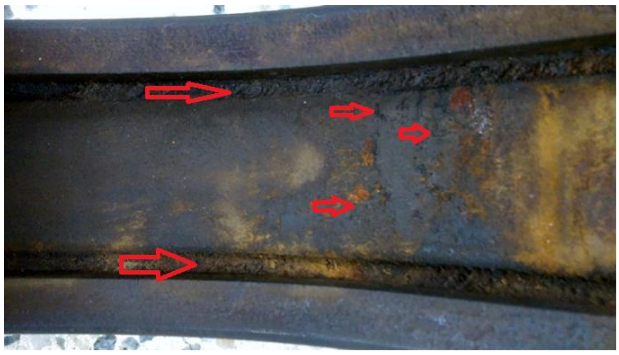
Optical microscopy identified different deterioration mechanisms distributed over the raceways and rolling elements. In the region shown in Figure 4, abrasive wear is observed on the steel raceway, with particle accumulation and appreciable material removal in the outer grooved areas, as well as particle embedding in the central region. This pattern is consistent with the ingress of external contaminant particles into the lubrication system. At the edges of the same region, particles detached from the bearing itself are observed, attributable to cavitation, most likely caused by the absence of an adequate filtration system in the lubrication circuit.

Fig. 4. Raceway region showing abrasive wear, particle accumulation, and material detachment.

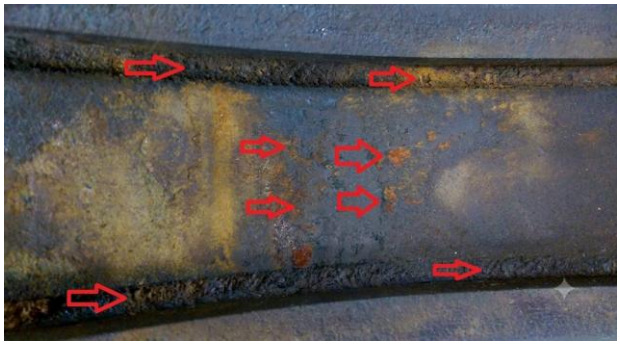
In an adjacent region of the raceway (Figure 5), cavitation wear was identified, characterized by material detachment associated with the intermittent implosion of bubbles generated by abrupt pressure changes in the oil, preferentially located along the direction of maximum applied load. Metallographic magnification of this area (Figure 6) revealed regions of extensive surface destruction, with cavity formation attributable to excessive vibration, oil contamination with abrasive particles capable of promoting foam formation, and inadequate clearance between the shaft and the bearing [15]; the striations observed in the central part of these images correspond to superimposed abrasive wear.

Fig. 5. Raceway region showing cavitation wear in the direction of maximum load.

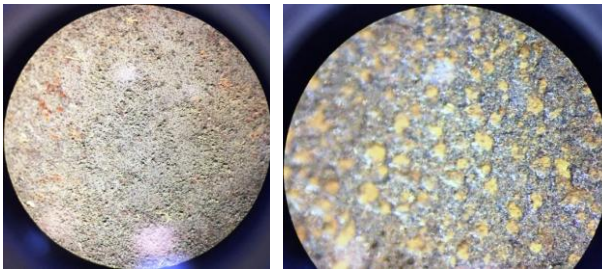
Fractographic analysis of the cylindrical rollers removed from the bearing (Figure 8) showed a deterioration pattern similar to that identified on the contacting steel raceways, dominated by abrasive wear. The corresponding micrographs (Figure 9) confirmed extensive areas where abrasive wear removed a considerable fraction of the metal surface; at 40× (Figure 9a), adhered metallic material is observed on the surface, while at 68× (Figure 9b), bronze-type material transferred from the cage to the roller is identified, evidencing that abrasive wear simultaneously affected the three components making up the bearing [16].

Fig. 9. Micrographs of the roller surface: (a) 40×, adhered metallic material; (b) 68×, transfer of bronze-type material onto the roller.

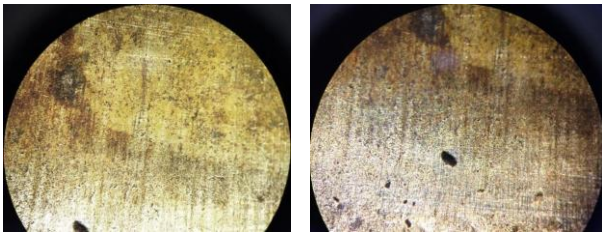
Finally, analysis of the bronze cage (Figure 10) revealed advanced adhesive wear, with transfer of metallic material from the steel roller, a direct consequence of insufficient lubrication between the parts [17]. Micrographs of two different regions of the cage (Figure 11) confirm zones of severe adhesive wear and appreciable metallic mass loss, evidencing that the degradation phenomenon affected the three main bearing components in a generalized manner.

Fig. 10. Wear present on the bronze cage, resulting from contact between metal parts and deficient lubrication.

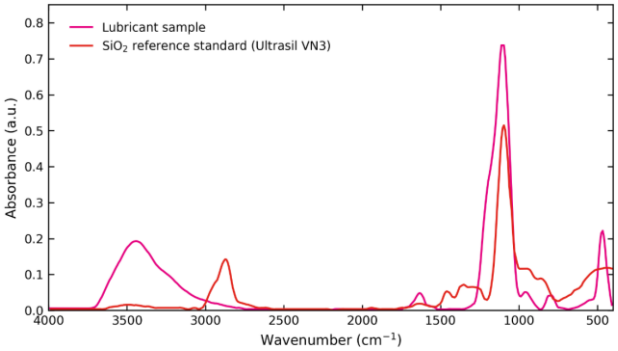
The FTIR spectra obtained for the lubricant samples (Figures 12 and 13) showed, in addition to the characteristic bands of the organic oil matrix, signals corresponding to inorganic substances foreign to the original

composition of the lubricant [18]. It should be noted that FTIR is primarily a qualitative technique: it does not allow direct quantification of the concentration of the identified contaminant, since the obtained signal depends on multiple factors, including particle size, distribution within the matrix, and spectral overlap with the organic bands of the oil; nonetheless, it enables the unambiguous molecular identification of the species present through their characteristic vibrational bands. In both spectra, the signals matched the SiO_2 reference patterns closely and consistently between the two samples analyzed, confirming the ingress of silica particles (sand or quartz) into the lubrication system.

Fig. 12. FTIR spectrum of oil sample 1, showing the presence of SiO_2 particles.

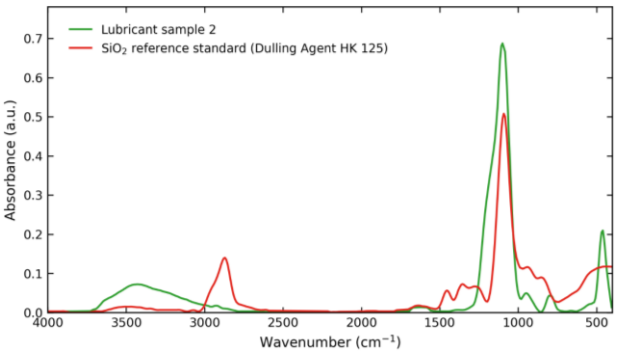
Fig. 13. FTIR spectrum of oil sample 2, confirming the presence of SiO_2 together with the other lubricant constituents.

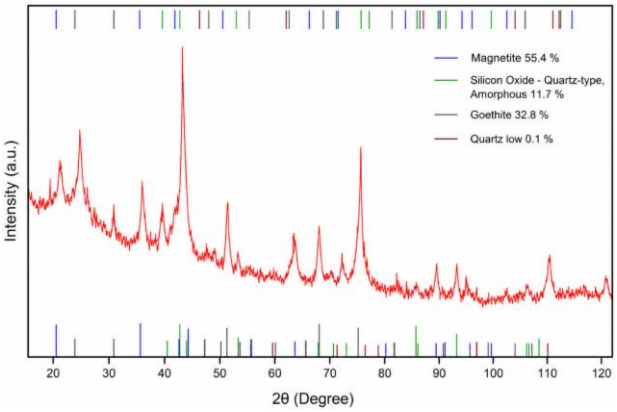
The diffractogram obtained for the metal surface of the radial bearing (Figure 14) identified magnetite and goethite as the main corrosion products, together accounting for 88.2%, along with a SiO_2 fraction close to 12%. This result is consistent with the severe wear observed on the metal parts and confirms the simultaneous presence of oxidation phenomena and mineral contamination.

Fig. 14. Diffractogram of the metal surface of the NU240 radial bearing.

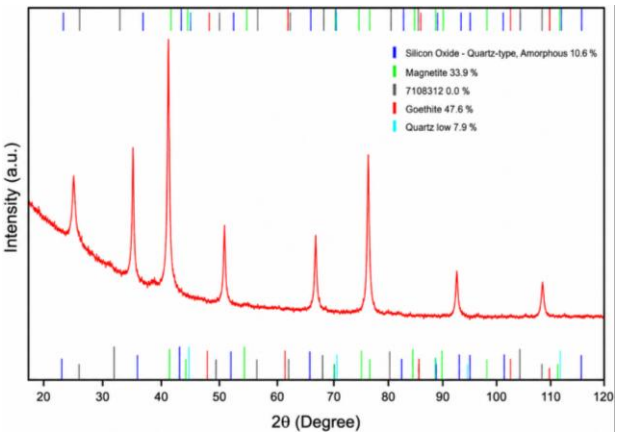
Analysis of the solid debris collected between the bearing parts (Figure 15), with an appearance corresponding to solidified lubricant, likewise showed corrosion products (magnetite and goethite) totaling 82%, together with 18% SiO_2 [19]. Based on this evidence, it was established that the contaminant responsible for the wear of the parts is of external origin, resides within the lubricant, and, due to the continuous movement of the components, tends to deposit on previously worn metal areas.

Fig. 15. Diffractogram of the solid debris recovered from the lubricant, showing corrosion products and SiO_2.

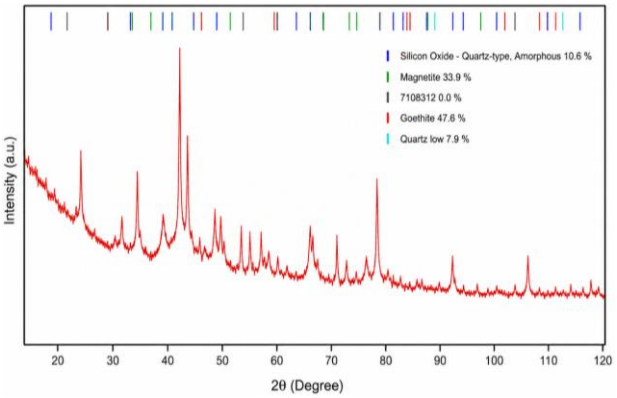
As a complementary sample, the roller surface of the 89456M axial bearing (Figure 16), which had been exposed to the environment, was also analyzed. In this case, magnetite was identified as the sole corrosion product, at a high proportion (71%) associated with sediments formed in an aqueous medium [20], together with a SiO_2 fraction of 29%. This result confirms that both the parts removed from the axial bearing and those from the radial bearing show an appreciable content of contaminant particles, and suggests that the higher relative proportion of silica in the axial roller may be related to its greater density relative to the lubricant, which favors its progressive sedimentation compared with particles suspended in the circulating oil.

Fig. 16. Composition spectrum of the contaminants identified on the roller of the 89456M axial bearing.

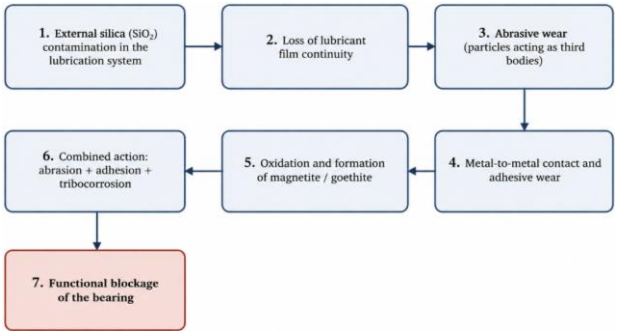
The integration of the evidence obtained from visual inspection, microscopy, FTIR, and XRD allowed a progressive bearing-degradation mechanism to be established, summarized schematically in Figure 17. Initially, the ingress of silica particles contaminated the lubricant and altered the tribological conditions of the contact; these particles acted as an abrasive third body, generating micro-cutting on the raceways and promoting increased surface roughness.

As abrasive wear progressed, the lubricant film lost continuity, allowing direct contact between the metal surfaces and promoting adhesive wear mechanisms. The continuous generation of metallic particles further increased lubricant contamination, while the rise in temperature and exposure of the base material favored the formation of magnetite and goethite as corrosion products. Finally, the combined action of abrasion, adhesion, and tribocorrosion produced a progressive increase in the resistance to motion of the rolling elements, culminating in functional blockage of the bearing and loss of system operability.

Fig. 17. Schematic of the proposed failure mechanism for the NU240 bearing, from external silica contamination to functional blockage of the component.

The absence of an effective filtration system in the lubrication circuit was identified as the operational factor that allowed the ingress and persistence of contaminant particles in the system, while the persistence of deterioration symptoms despite routine lubricant readings within the manufacturer's limits highlights the need to review the sensitivity of the monitoring criteria used in predictive maintenance programs.
